Appendix 1
JUNE 2014 DICKEY BROOK RAPID STREAM ANALYSIS
FOR THE PEEKSKILL URBAN WATERSHED PROJECT

Conducted by Hudson River Sloop Clearwater, the Peekskill Urban Watershed Council, and the Youth Environmental Stewards from the Peekskill Youth Bureau, with assistance from Andrew Fischer of the Hollow Brook Water Watch and John Gebhards of the Quassaick Creek Watershed Alliance.

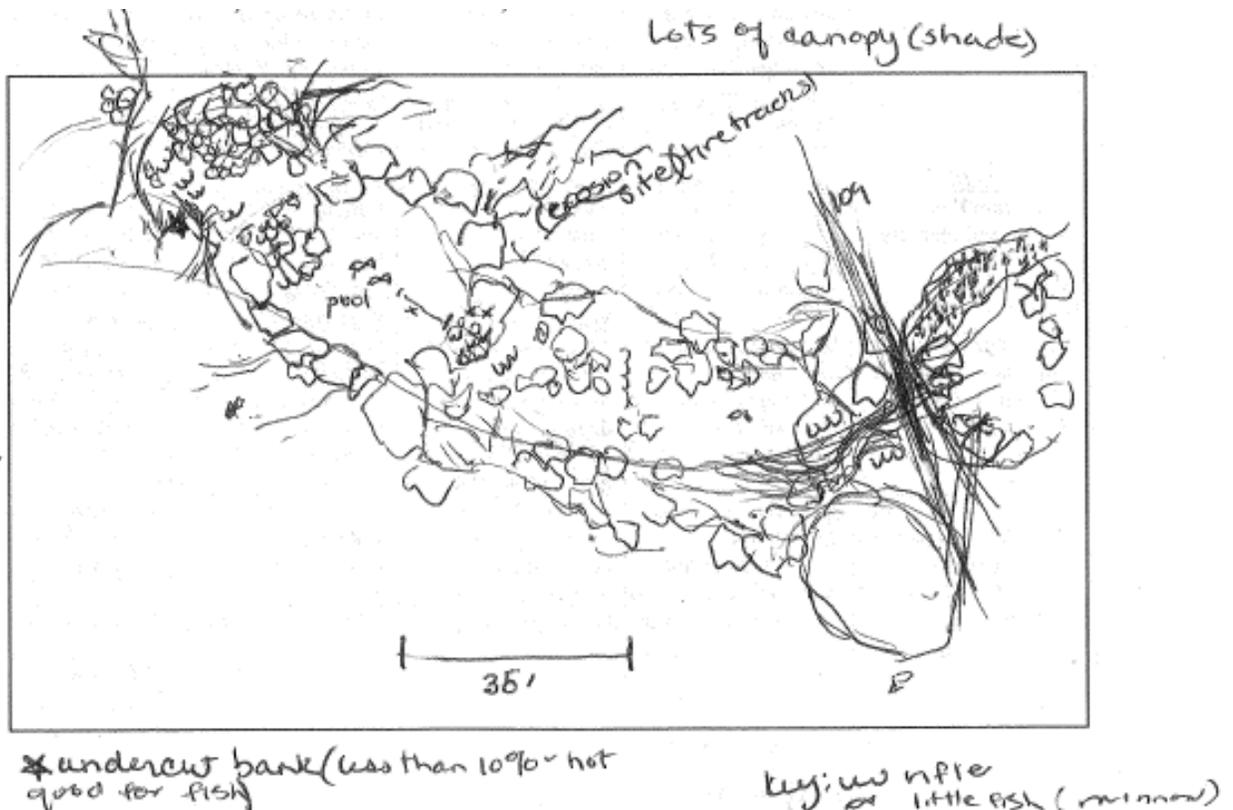
3.2.2.4 Site Sketch

Channel stability was not analyzed by shape, but some undercutting of the bank was noted (as indicated on site sketch), but it was less than 10%. Also noted were tire tracks, as explained above. The overall canopy was substantial, with a mix of trees, shrubs and grasses; most trees were upright, with few recent tree falls.

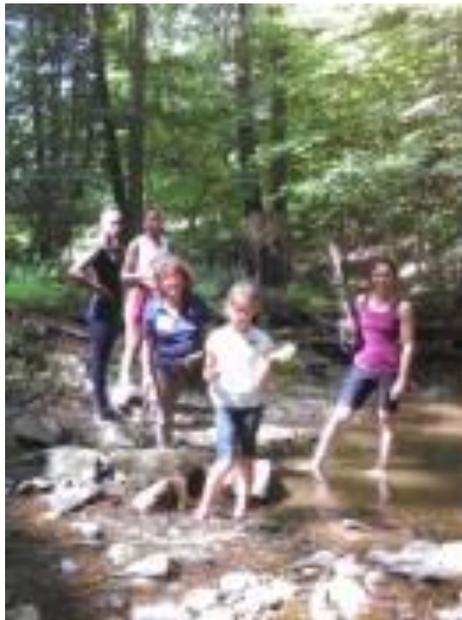
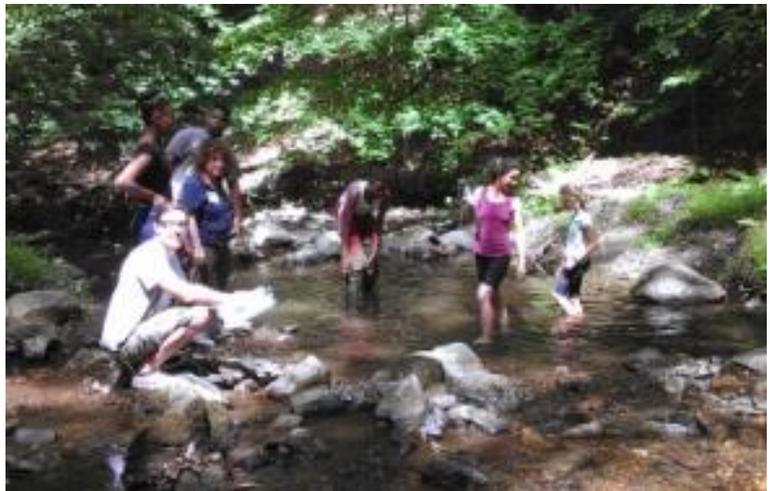
Substrate Type Table (Record 25 values)

Substrate Type	Silt/Clay/Mud (makes the water cloudy if disturbed)	Sand (< 0.1")	Gravel (0.1-2")	Cobble (2-10")	Boulder (> 10")	Bedrock (solid rock covers stream bottom)
Tallies						
Number of Tallies				5		
Percent (multiply # of Tallies by 4)				20

Embeddedness Table (Record 10 values)

Cobble #	0-25%	25-50%	50-75%	75-100%
Tallies				
Number of Tallies	4	3	2	4
Percent (multiply # of Tallies by 10)	40	30	20	40

Embeddeness of Cobble and Boulders ranged from 8/20 at 0-25%; 3/20 at 25-50%, 2/20 at 50-75% and 7/20 giving an overall embeddeness score of 40%, which is good on the RSAT evaluation method.

Substrate conditions showed 3/25 sand; 2/25 gravel; 14/25 cobble; 6/25 boulder, with no silt/clay/mud or bedrock at the site tested.
